GNRO-2015/00019

April 08, 2015

SUBJECT: Licensee Event Report (LER) 2015-001-00 Automatic Actuation of the  
Reactor Protection System (RPS) Due to a Main Turbine Trip  
Grand Gulf Nuclear Station  
Docket No. 50-416  
License No. NPF-29

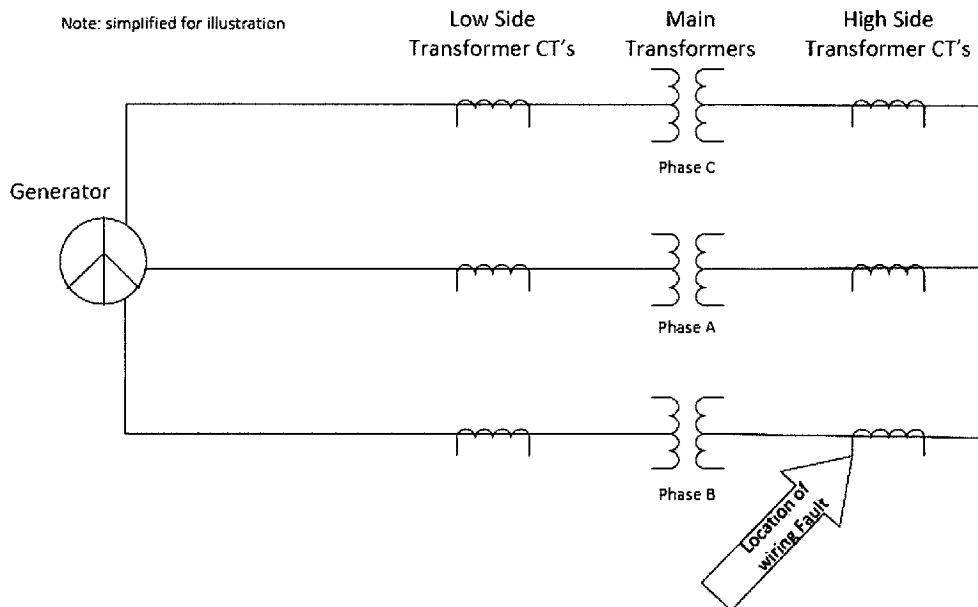
The high voltage side (500kV) CT wiring is normally grounded in the 801 panel in the control room. An unintentional, high voltage CT wiring ground developed inside the conduit mounted on top of "B" main transformer. The high voltage CT provides input to the transformer differential relay located in the control room. The differential relay is a protective relay that compares the difference in power between the high voltage side and low voltage side (22kV) of the transformer. The transformer is protected by actuation of the transformer differential relay and generator trip.

1. A ground developed on the high voltage CT wire inside the conduit on top of the transformer. This ground created circulating ground currents between the normal ground in the control panel and the fault location on top of the transformer. This current caused localized heating that resulted in melting the other wiring in the conduit.
2. The change in current through the high voltage CT, without a change in the low voltage CT current, was detected by the transformer differential relay, resulting in relay actuation and subsequent generator trip.

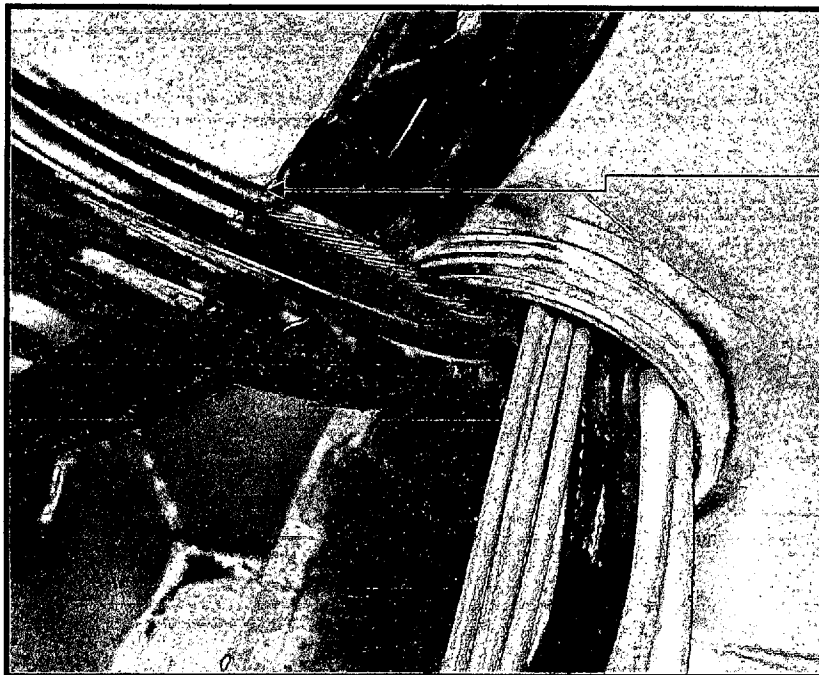
Damaged wiring was in pull box #3.

The faulted cables and other similar cables were determinated and alternate wiring and conduit was installed The extent of condition involved replacing the wiring and conduit for the protective circuitry on both the high voltage and low voltage sides on all three recently installed single phase main transformers.

Corrective actions were taken to  
replace wiring and conduit
